## Report of Infrared Electrical Survey

**FOR:** Your Company  
Any Town, USA

**JOB:** 0609  
**CAMERA:** Inframetrics 395

**SURVEY DATE:** January 27, 28, 2006

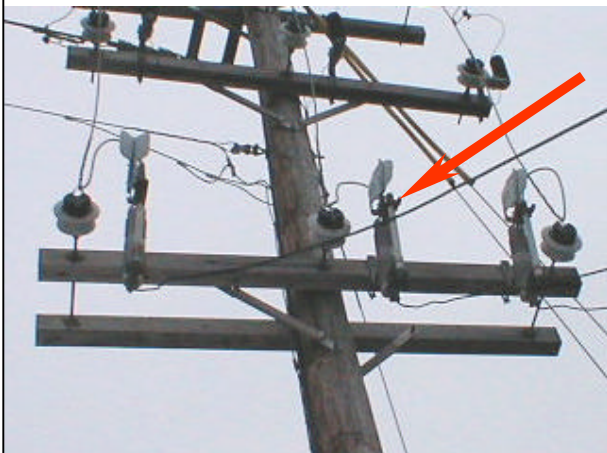
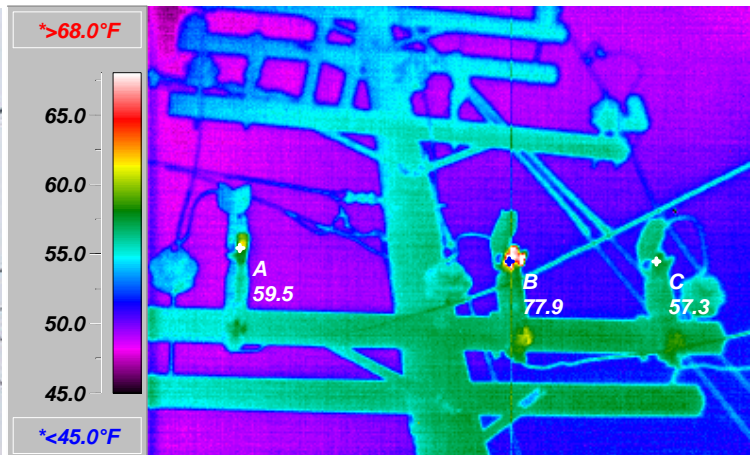
**Item #:** 0412-PR-01 **Time:** 1056 **Date:** 2/05/04 **Emissivity:** .99 **Technician:** Jim Garner

**General Location:** Eastside Substation

**Equipment Identification:** Pole # 640668

**Component:** Primary Disconnect

**Other:** Latch End

**Temperatures:** Phase A: 59 Phase B: 77 Phase C: 57 L1: L2:

**Δ Temperatures:** 20 **Priority Assigned:** 3

**Probable Cause:** Loose and Dirty Primary Latch Connection

**Recommendations:** Disassemble and Inspect, Notify Utility Company, Replace Disconnect?

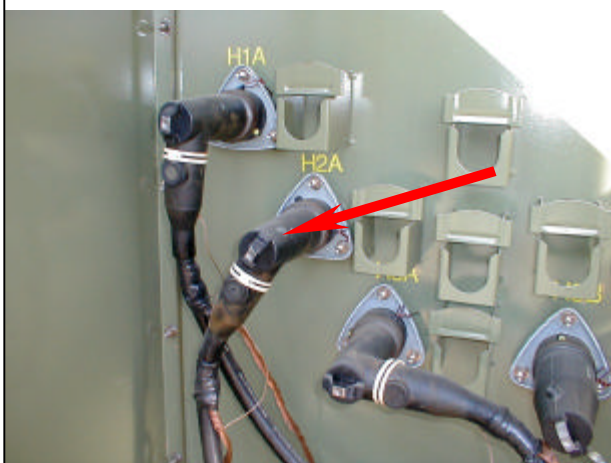
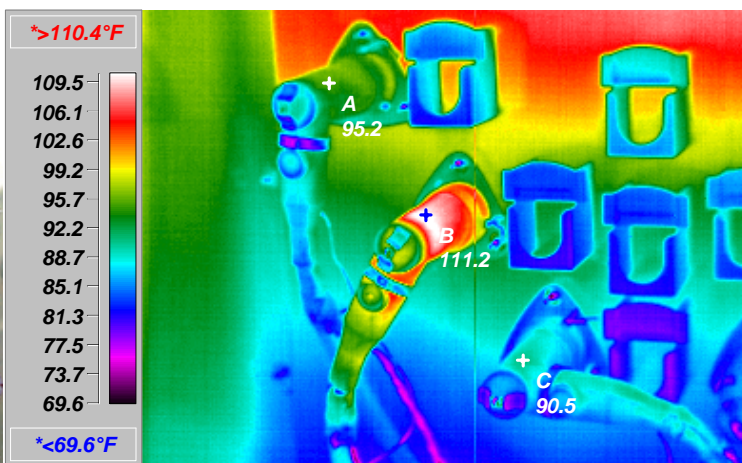
**Item #:** 0412-MT-02 **Time:** 0930 **Date:** 2/18/04 **Emissivity:** .99 **Technician:** Jim Garner

**General Location:** Southeast Substation

**Equipment Identification:** 2500 KVA Transformer # 00J202248

**Component:** Primary Elbow

**Other:** Phase H2A

**Temperatures:** Phase A: 95 Phase B: 111 Phase C: 90 L1: L2:

**Δ Temperatures:** 21 **Priority Assigned:** 3

**Probable Cause:** Loose and Dirty Connection, Faulty Elbow

**Recommendations:** Disassemble and Inspect, Notify Utility Company to Replace Elbow

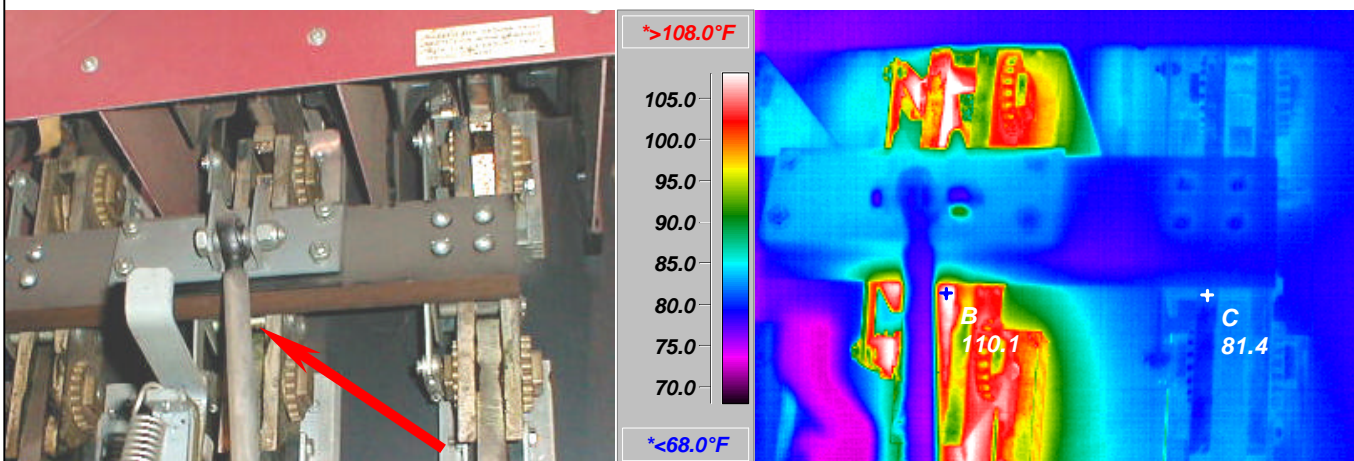
**Item #:** 0417-03      **Time:** 0837      **Date:** 2/27/04      **Emissivity:** .99      **Technician:** Jim Garner

**General Location:** Main Electrical Distribution Platform # 2

**Equipment Identification:** Main Disconnect

**Component:** 3000 Amp Fused Disconnect

**Other:** Internal Heating, Hinge & Knifeblade

**Temperatures:**      **Phase A:**      **Phase B:** 110      **Phase C:** 81      **L1:**      **L2:**

**Δ Temperatures:** 29      **Priority Assigned:** 3

**Probable Cause:** Internal Heating, Hinge & Knifeblade Failure

**Recommendations:** Disassemble and Inspect, Clean Hinge, Knifeblade & Receiver, Set Torque to Manufacturer's Specs.

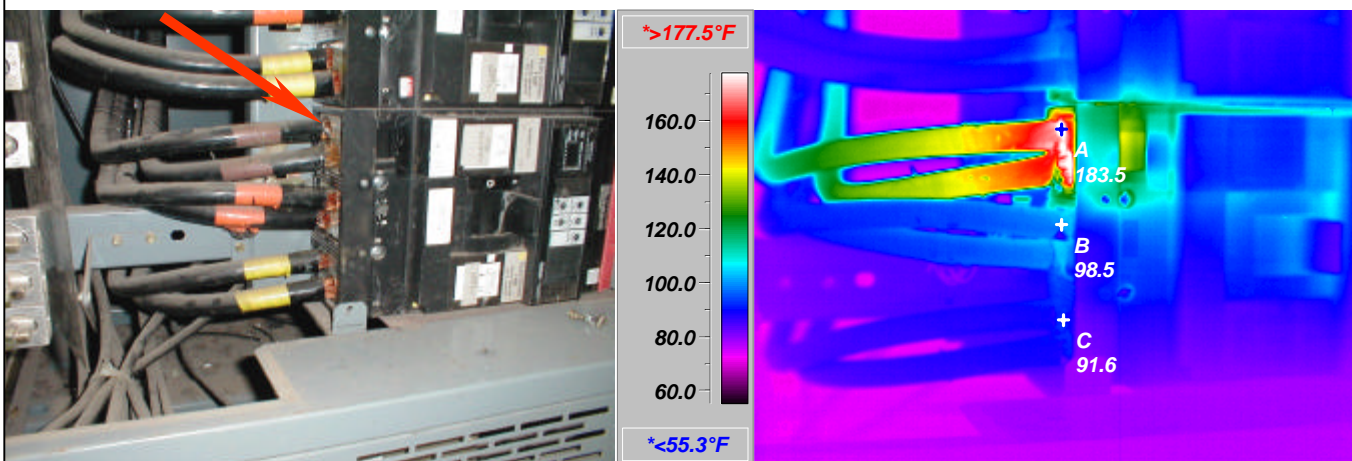
**Item #:** 0412-MB-04 **Time:** 0853 **Date:** 2/23/04 **Emissivity:** .99 **Technician:** Jim Garner

**General Location:** Electrical Distribution Room # 1 / Distribution Panel # 3

**Equipment Identification:** Feeder for Chiller # 1

**Component:** 800 Amp Breaker

**Other:** Wire & Connector

**Temperatures:** Phase A: 183 Phase B: 98 Phase C: 91 L1: L2:

**Δ Temperatures:** 92 **Priority Assigned:** 1

**Probable Cause:** Loose and Dirty Connection

**Recommendations:** Disassemble and Inspect, Clean and Tighten Wires & Connector

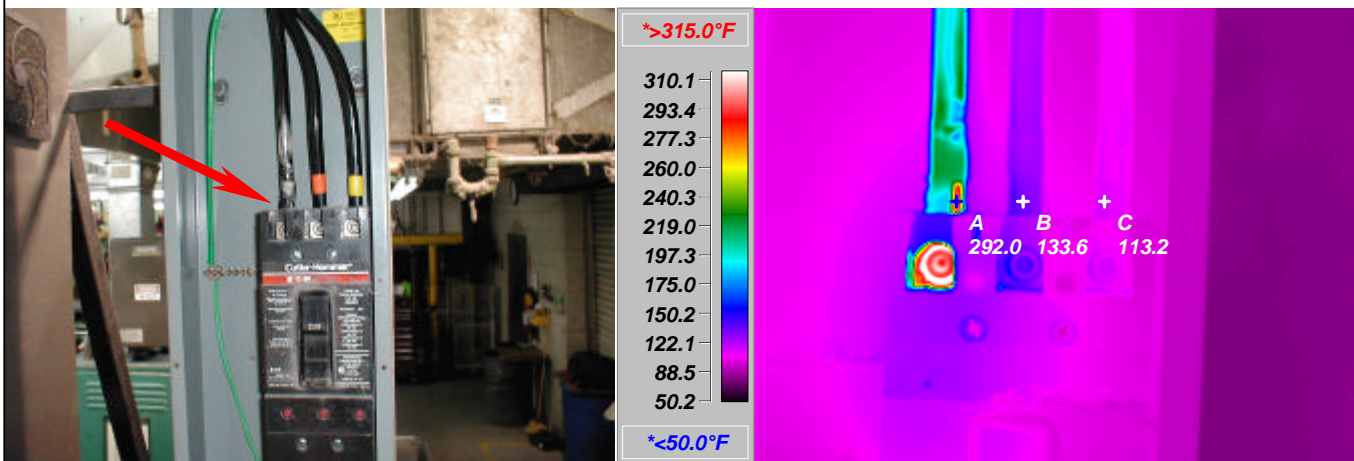
**Item #:** 0412-HS-05    **Time:** 1059    **Date:** 2/19/04    **Emissivity:** .99    **Technician:** Jim Garner

**General Location:** Muschamp Twisting Department

**Equipment Identification:** Feeder for Twister # 6

**Component:** 200 Amp Breaker

**Other:** Wire & Sta-Kon Connector

**Temperatures:**    **Phase A:** 292    **Phase B:** 133    **Phase C:** 113    **L1:**    **L2:**

**Δ Temperatures:** 179    **Priority Assigned:** 1

**Probable Cause:** Loose and Dirty Connection, Faulty Splice/Crimp, Insulation Failure

**Recommendations:** Disassemble and Inspect, Clean Wire, Rewire Connection

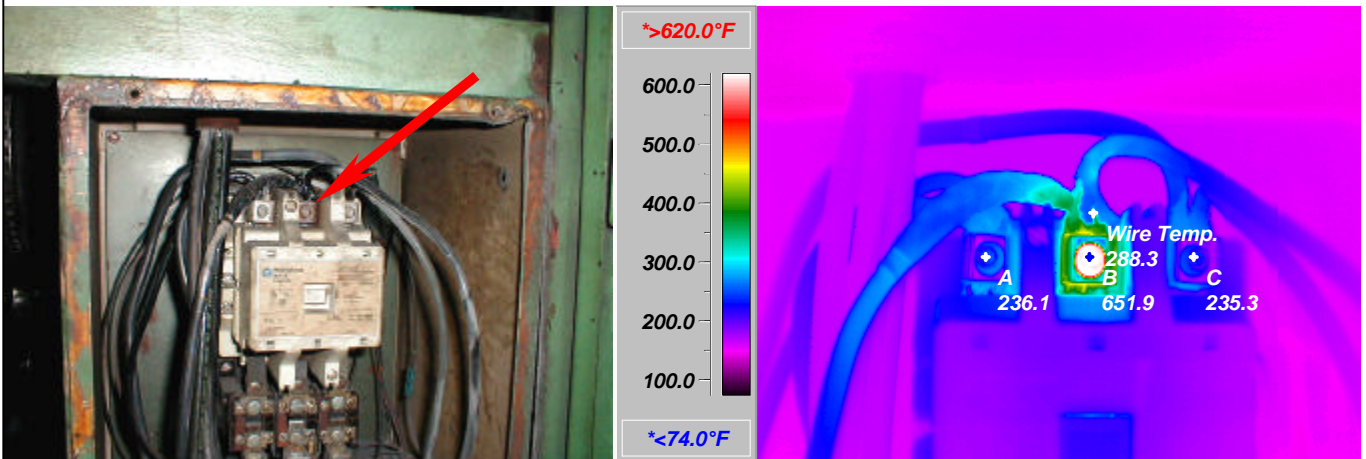
**Item #:** 0412-V-07    **Time:** 1100    **Date:** 2/06/04    **Emissivity:** .99    **Technician:** Jim Garner

**General Location:** Twisting Department

**Equipment Identification:** Muschamp Twister # 2 Control Cabinet

**Component:** Starter MC-1

**Other:** Wire & Connector / Insulation Failure

**Temperatures:**    **Phase A:** 236    **Phase B:** 651    **Phase C:** 235    **L1:**    **L2:**

**Δ Temperatures:** 416    **Priority Assigned:** 1

**Probable Cause:** Loose and Dirty Connection, Insulation Failure

**Recommendations:** Disassemble and Inspect, Clean Connector, Rewire Connection

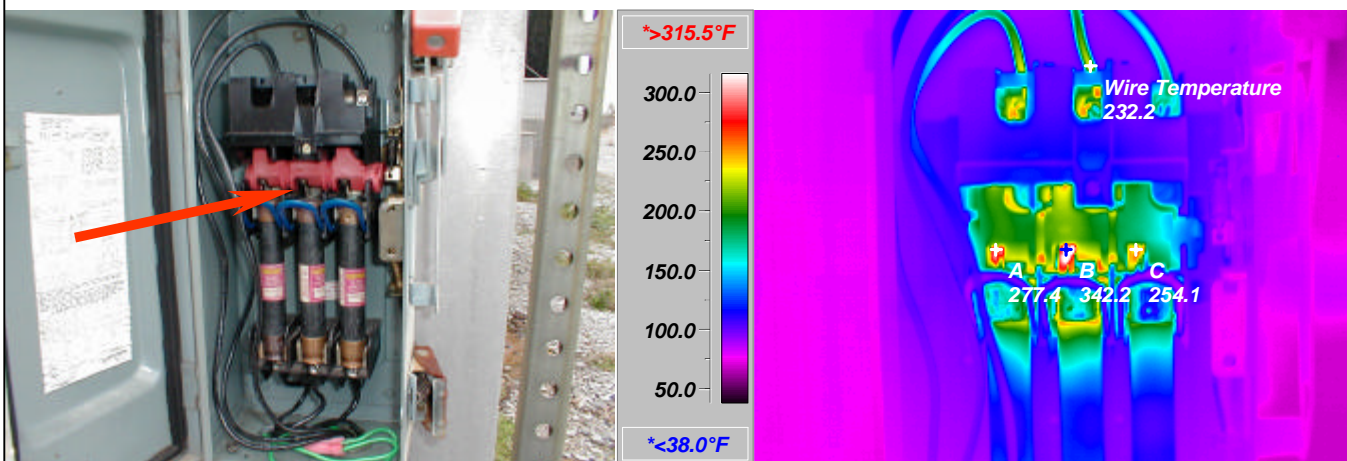
**Item #:** 0412-MB-08 **Time:** 1217 **Date:** 2/23/04 **Emissivity:** .99 **Technician:** Jim Garner

**General Location:** Outside South End Superba 100 Ton Cooling Tower

**Equipment Identification:** Feeder for Pump P-2

**Component:** 30 Amp Fused Disconnect

**Other:** Internal Heating, Hinge & Knifeblade

**Temperatures:** Phase A: 277 Phase B: 342 Phase C: 254 L1: L2:

**Δ Temperatures:** 98 **Priority Assigned:** 1

**Probable Cause:** Loose and Dirty Connection, Hinge & Knifeblade Failure

**Recommendations:** Disassemble and Inspect, Clean Wires, Replace Disconnect, Inspect for Possible Wire Insulation Failure

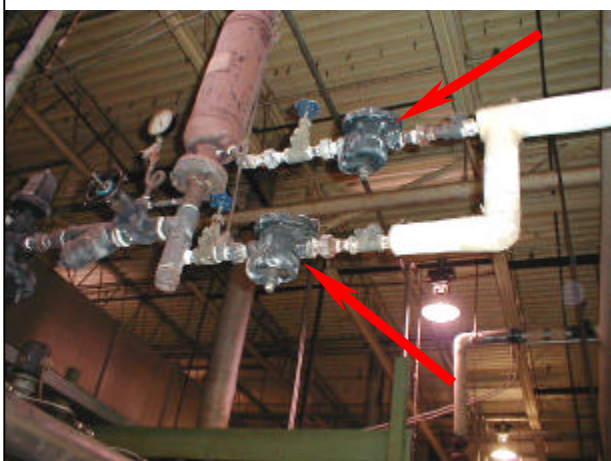
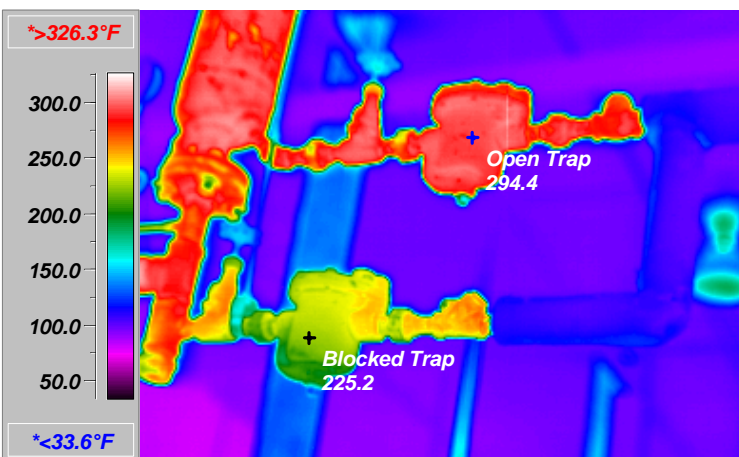
**Item #:** 0412-HR-09 **Time:** 1045 **Date:** 2/03/04 **Emissivity:** .99 **Technician:** Jim Garner

**General Location:** Heat Set Department

**Equipment Identification:** Suessen Machine # 6 Steam Traps

**Component:** Top Trap Open

**Other:** Bottom Trap Blocked

**Probable Cause:** Blocked Strainers or Traps

**Notes:** **REPAIR IMMEDIATELY!**

**Recommendations:** Clean Strainers and Traps, Replace Traps?

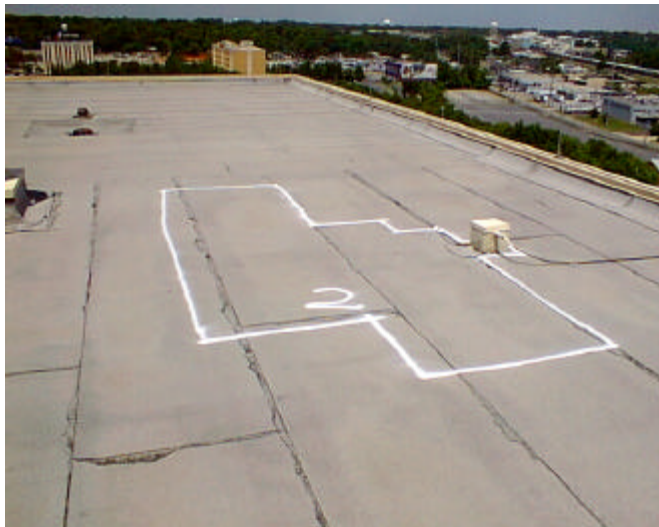
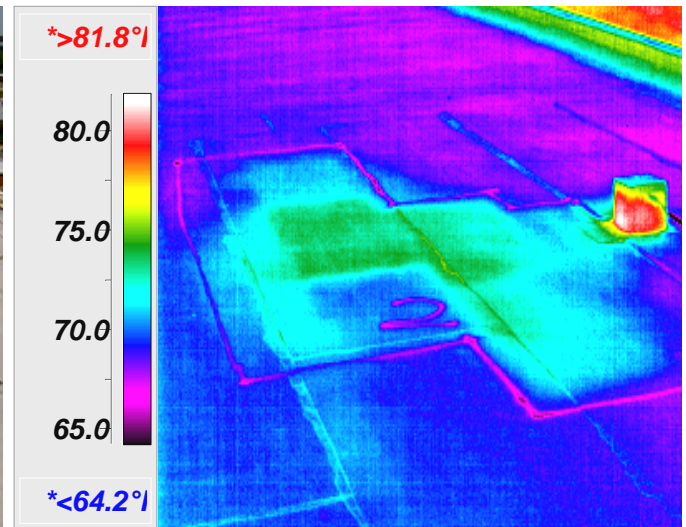
**Item #:** 0065-10

**General Location:** Building A3, 13th Floor Roof

**Description:** North Side

**Size:** 8 X 11.5

**Square Footage:** 92

**Notes:** Remove & replace wet insulation, reroof area. Approximate cost 92 x \$2.50 = \$230.
